1234 Main St.
Toronto ON M6S 5A5

5/25/2017

Proper Home Inspections, Inc. o/a HouseMaster

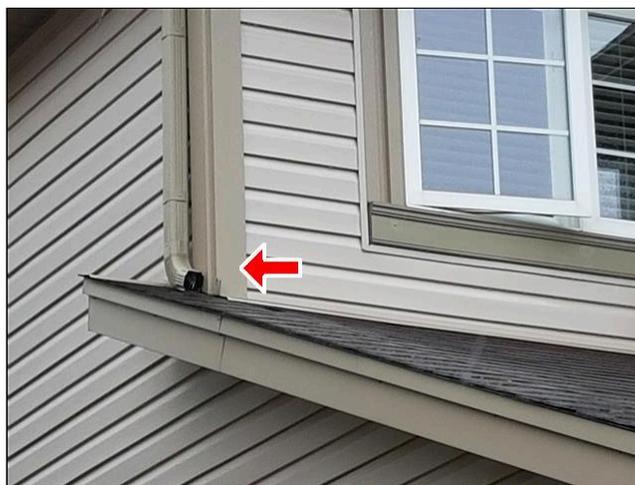
1.5(1) DOWNSPOUTS / ROOF DRAINS Image 1

●					1.0 ROOF COVERING
●					1.1 EXPOSED FLASHING Minimal visible flashing. All flashed areas, including chimneys, vent pipes and valleys should be checked periodically for wear or damage and should be repaired or sealed as needed.
●					1.2 PLUMBING STACKS
●					1.3 VENTILATION COVERS
●					1.4 RAIN GUTTERS
●					1.5 DOWNSPOUTS / ROOF DRAINS (1) Downspout discharge onto lower roofs can cause leakage/premature wear. This condition should be monitored or corrected to ensure that no consequential damage occurs. Recommend running a leader to the gutter. (2) Downspouts that run into the ground are subject to backup/blockage. Neither the presence nor integrity of underground lines, nor free flow of water through such lines is determinable as part of this inspection. Recommend re-directing to ground as required and/or desired.
●					1.6 FASCIA / SOFFITS

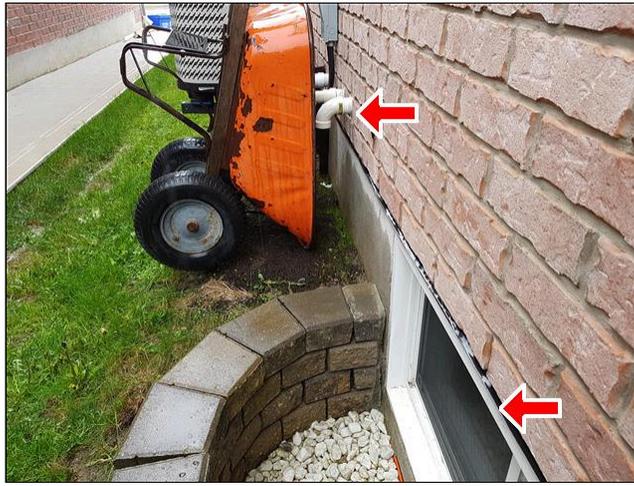
3.11 DRYER/OTHER EXTERIOR VENTS Image 1

●				3.7 RAILINGS Railings missing at deck. Handrails or guardrails should have the proper height and balusters spacing, and should be securely installed for proper protection. In general, spacing between spindles/pickets should be no more than 4 inches; guards are required for surfaces greater than 24 inches in height; and handrails are required along stairways of 3 or more steps. Consult a qualified contractor or the municipality for local requirements.
●					3.8 FOUNDATION COATING
●					3.9 ELECTRIC / GFCI(S)
●					3.10 EXTERIOR FAUCET(S)
		●			3.11 DRYER/OTHER EXTERIOR VENTS Vents for fuel burning appliances require proper clearance from windows and doors to reduce the potential of combustion gases (like carbon monoxide) from re-entering the home. For health safety, confirm and provide adequate distance/clearance for vents from windows and doors.

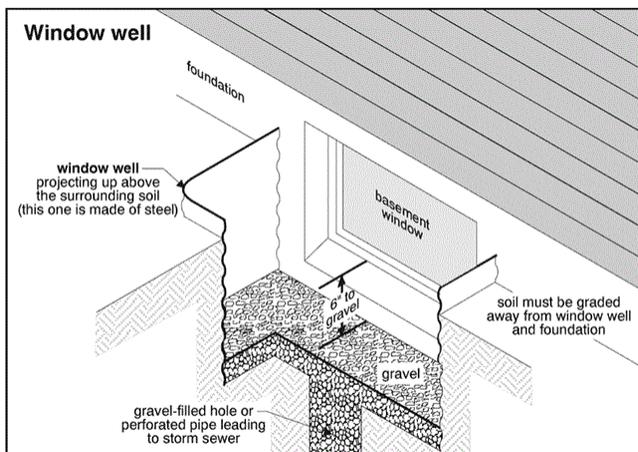
4.2 WINDOW WELLS. Image 1

●					4.0 WALKWAYS
	●				4.1 DRIVEWAY Sealing joint/crack between home and driveway/walks/patio may prevent moisture penetration into foundation/home and reduce settlement. Recommend sealing/resealing as needed.
●					4.2 WINDOW WELLS. Window wells can help minimize soil/water seepage into sub-grade areas; however, drains, if present, must be kept clear. Covers may help prevent rainwater accumulation and should be installed where warranted.
●					4.3 GROUND SLOPE AT FOUNDATION To reduce the amount of water run-off or ponding and potential for water penetration and/or structural concerns, a positive slope away from the foundation should be provided around the perimeter of the house. Maintenance of a suitable ground cover is also advised.
●					4.4 SITE GRADING Houses near hillsides and low laying areas are prone to drainage concerns. The property is located near or on a hillside. To reduce the potential for water runoff that could adversely affect the house structure and/or result in water penetration, proper contouring (grading) of the site and/or along the foundation should be provided. Drainage provisions may also be required. Particularly around back porch.

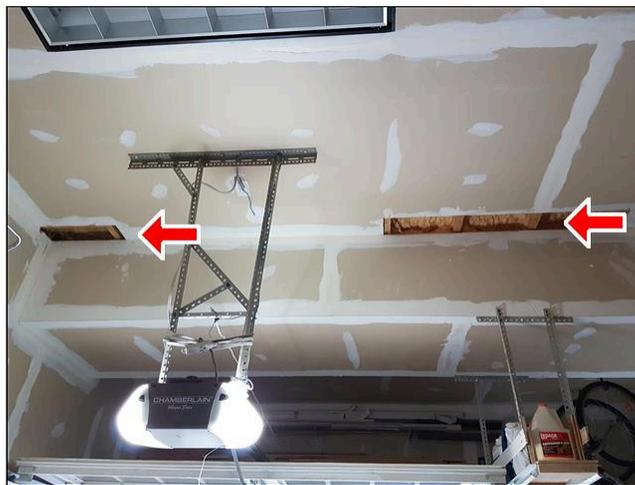
5.1 WALLS / CEILINGS Image 1

●					5.0 FLOOR SLAB
	●				5.1 WALLS / CEILINGS Any openings in the wall or ceiling between the house and garage, including any hatches or doors, should be covered to provide an adequate air barrier separation between a garage and the interior to prevent the potential infiltration of carbon monoxide into the home. Taped and sealed drywall, or another appropriate wall/ceiling cover, is required for safety. Consult a qualified contractor for further recommendations and estimates.
●					5.2 VEHICLE DOOR(S) Exception: Left hand door (looking front to rear) could not be operated due to storage. Recommend check during closing walk through.
●					5.3 DOOR OPERATOR(S)
●					5.4 ELECTRIC / GFCI. The evaluation of electric fixtures and devices throughout the property is based on inspection of random, representative units; different conditions may be found at any particular fixture or device.
	●				5.5 HOUSE / SERVICE DOOR(S). Door requires closer. Repair/install as required.
